EFFECTS OF DEVELOPMENT ACTIVITIES IN SANJAY GANDHI NATIONAL PARK, MUMBAI ON VIHAR LAKE BODY AND BHANDUP HILLS, MUMBAI

Prof. (Dr.) Surendra C. Thakurdesai
Head, Department of Geography,
R P Gogate and R V Jogalekar College, Ratnagiri.

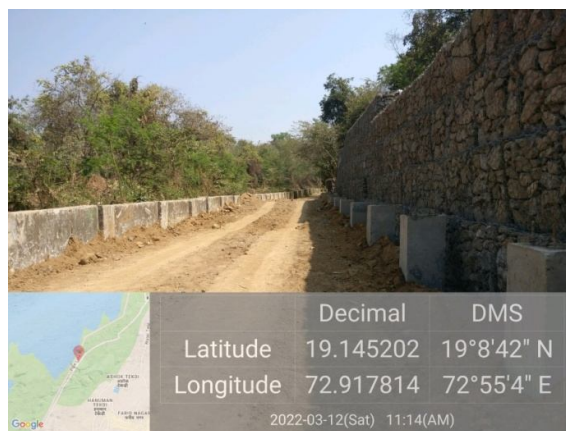
The site visit reveals the nature of changes brought about and the destruction caused by the construction activity. Following photograph shows the placement of track over the slope segment. It clearly indicates that the track is neither at top nor at foothills. Thus it is inevitable to undertake cut and fill activity to create flat surface for track construction.

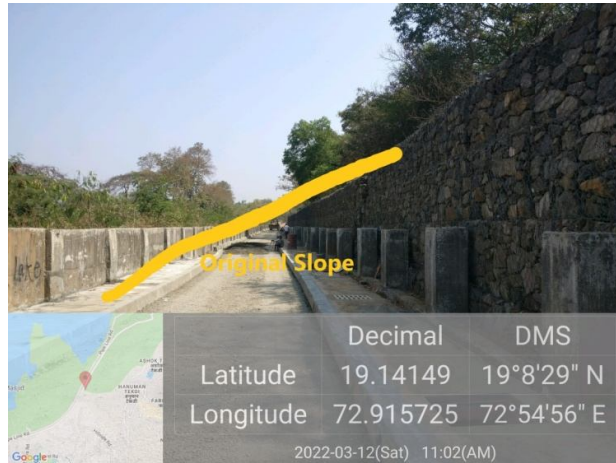
As there is cut and fill activity it is bound to create a steep slope which will be vulnerable to failure. The vulnerability is high especially due to high rainfall regime. To protect these newly created steep slopes gabion walls are constructed. The height of wall is indicator of the extent of cutting done at site. Following photograph shows the retention structure in form of gabion wall and the original slope marked on it.

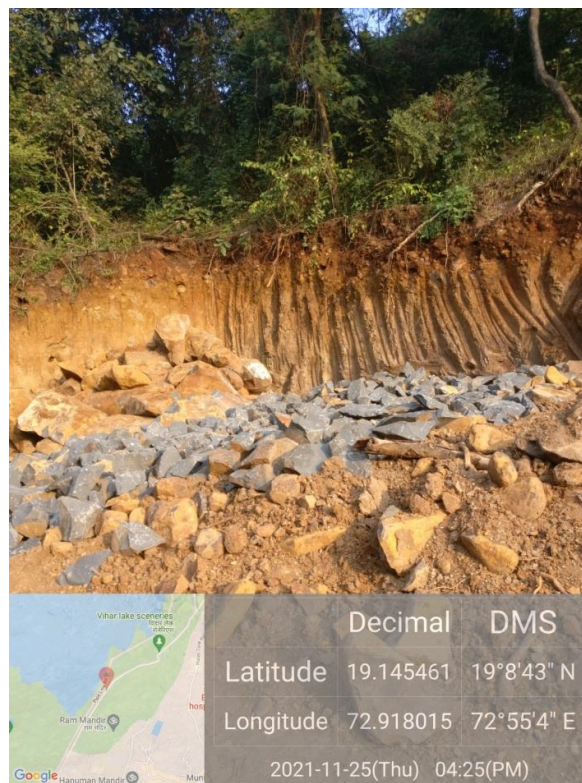
Even if the slope cutting is denied by the authorities following photographs clearly show the cutting activity going on. The slopes are modified up to bedrock level and there are exposures of bedrock layers over the fresh slopes. Following photo shows freshly cut and exposed bedrock.

Large scale changes in the hill slopes are a cause of concern as they are likely to trigger chain of effects in the whole catchment. Cutting of slopes for widening of track is major change brought about. The cutting has created steep slopes with angle as high as 80°. The fresh slope cuts have exposed the bedrock upper loose regolith and bedrock. Loosened material is sliding along the steep slopes even in dry spell. The sliding is definitely going to increase with monsoon rains. Gabion structures are used to

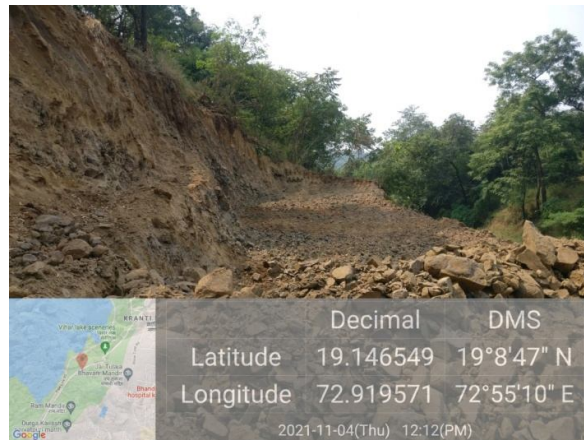
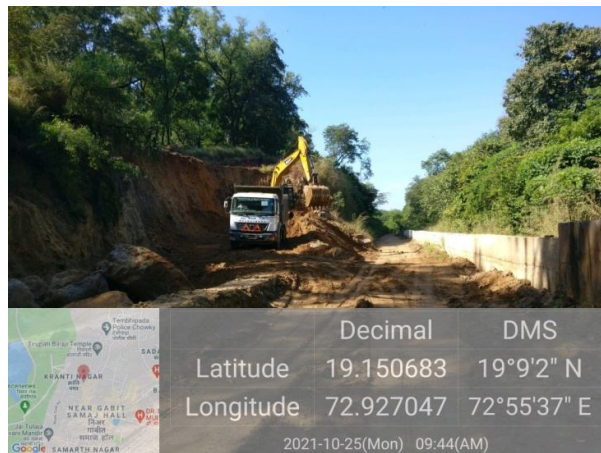
The bedrock is further cut and boulders are removed. These are used to construct gabion structures and at some places as landfill material. Excess material is removed at many places and the gaps between cut slope and gabion wall is filled with mucking generated. For this roads are constructed over the cuts as seen in following photograph.
