**Article :Study on Landslide Incidents of Paglajhora and Adjacent Areas –An Overview; Kurseong Block, Darjeeling, India**

**Author :Tamal Basu Roy AND Snehasish Saha**

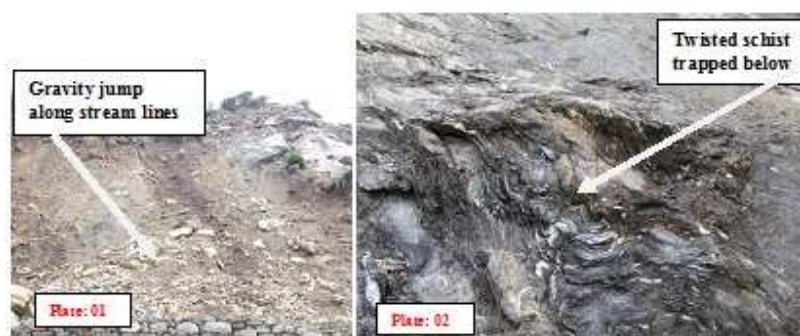
The main motive was to find out the major landslide types with a view to assess the nature of failure and to make a causal relationship between the processes involved and their concentration of slumping, jumping, sliding, creeping, flowage, etc. Here the mobile Rapid flow and the slow flow types were identified to attempt the nature of jump in response to the gravitational pull.

In the following Photograph scenario of 10 May Paglajhora slide has been conceptually evaluated.

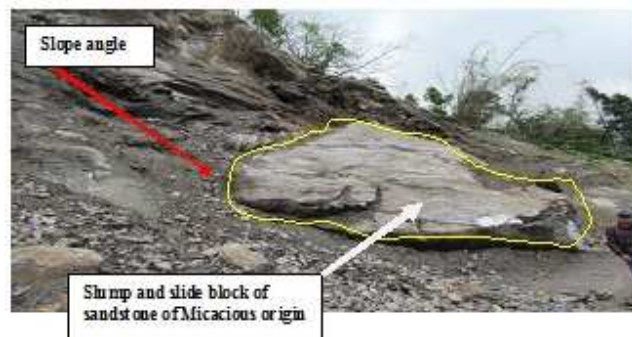
- a) Block Slide: Witnessed downward movement of erratic chunks of rock along the lubricated subsurface plane of detachment.

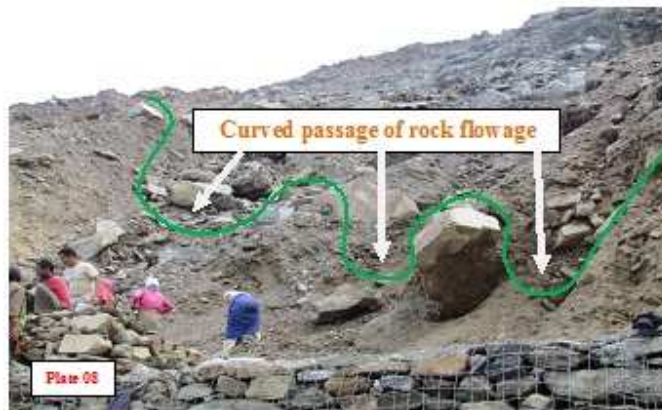
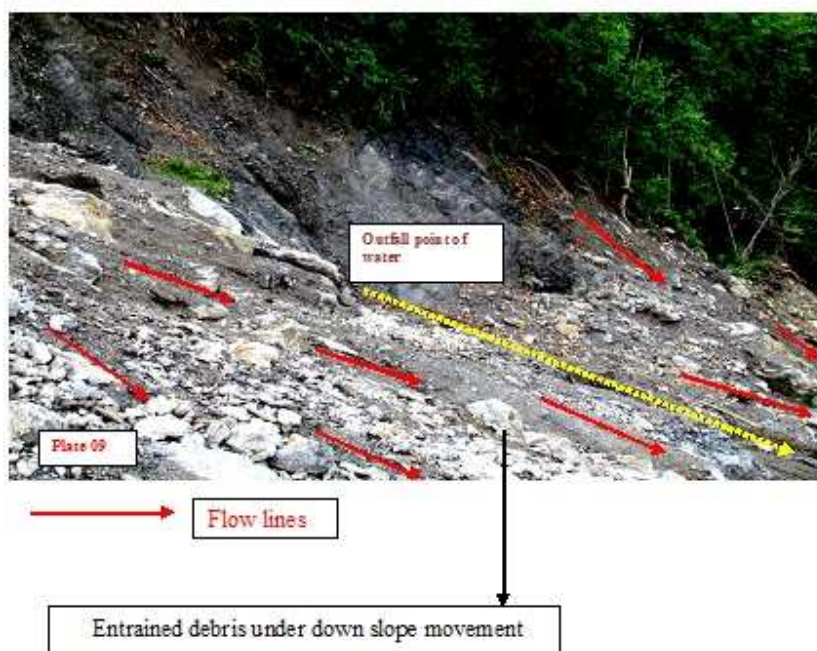
Movement of fine to finer materials along curved planes has been observed predominantly either as mud flow or soil flow accompanied by polygonal scree products. (Ref: Plate 08)

b) Debris Flow-downward flow of detritus as dominant material

c) Earth flow-flow of mixed earthen saturated substances.
